MILLER BREWING COMPANY

Description:
Humidifier pan repair

GRUNAU COMPANY'S RESOURCEFULNESS SAVES MONEY FOR MILLER BREWING COMPANY

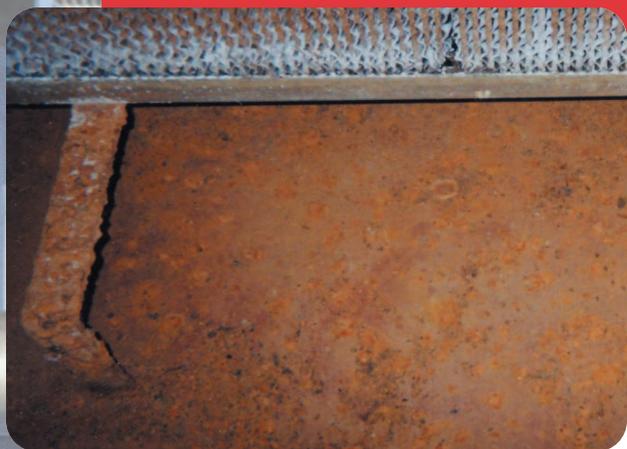
An HVAC unit's humidifier pan was corroding and in need of immediate attention.

A metal pan used to collect condensate in summer and hold humidification water in winter for an HVAC unit at the Miller Brewing corporate offices was corroding and needed repairs. The pan was attached to a larger unit that would have been very costly to replace and would have required the removal of coil supports. Instead, the service team encased the existing pan with a plastic-like pouring product called Pancrete. This repair method allowed the pan to be used without further corrosion and eliminated the need to remove or replace any of the unit's components.

Grunau repaired the humidifier pan at half of the cost of installing an entirely new unit. The Pancrete, a hard plastic-like material, also will save Miller maintenance costs in the future because it is more durable and long-lasting than typical metal pans.

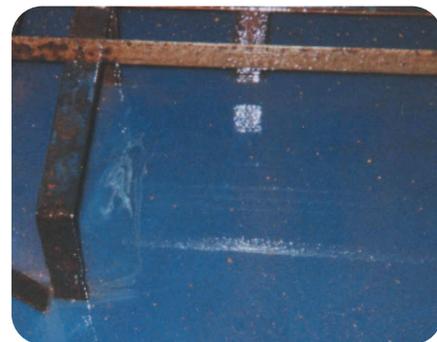
Grunau's recommendation to use a hard plastic-like material to encase the pan, instead of replacing it, saved Miller money and made the equipment more durable.
